• PROFESSIONAL • BOATBUILDER

Infrared Imaging

Skeptical of this technology? So was the author, until he watched it accurately map areas where water was trapped in the cored bottom of a 15-year-old FRP sailing yacht.

by David King

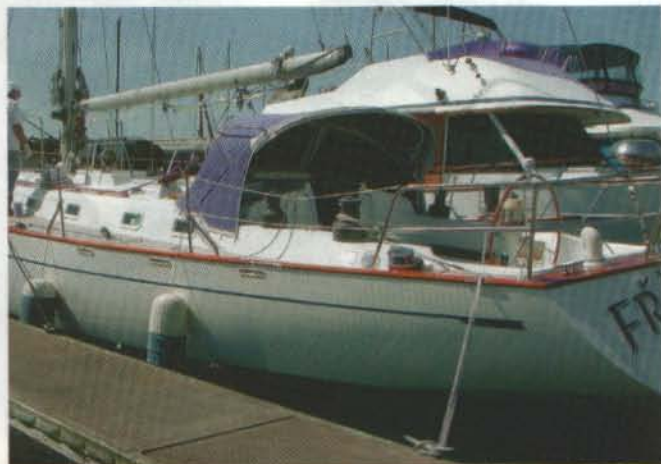
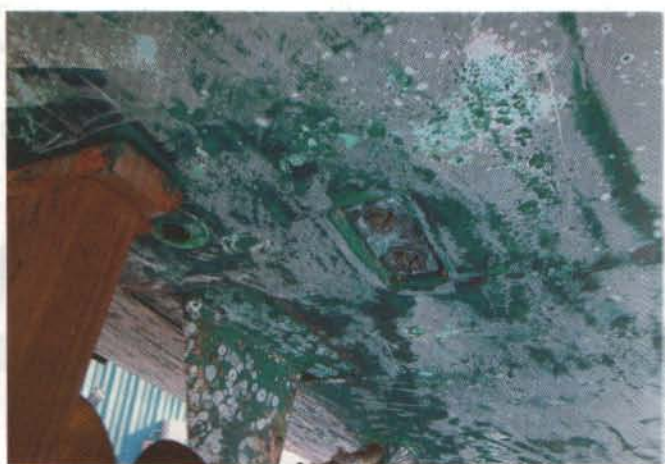
The 52' (15.8m) sailboat pictured above (left) came to Townsend Bay Marine (Port Townsend, Washington) for repair of the deep and pervasive osmotic blisters on her bottom (right), as well as for maintenance items and upgrades. TBM's original plan: peel the bottom, then leave the boat outside for some time to allow the boat to dry before relaminating.

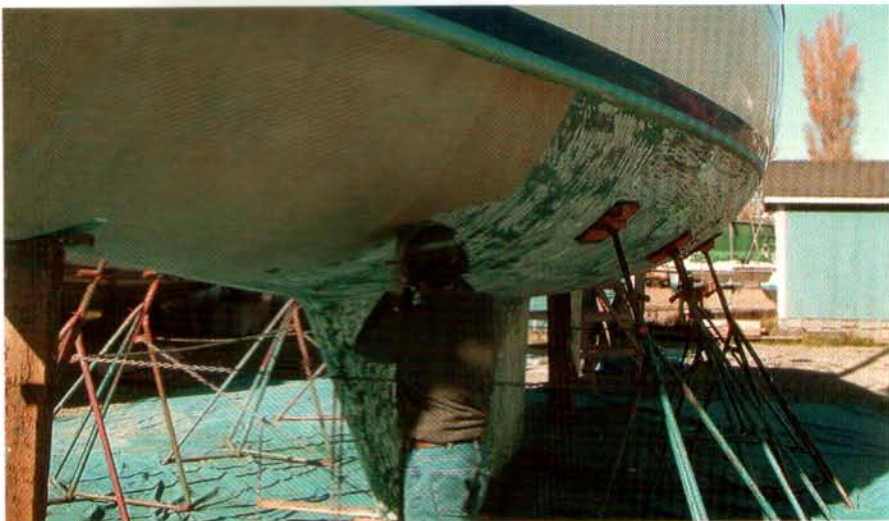
The bottom actually had to be peeled twice, due to the poor condition of the outer laminate. Still, the hull failed to dry out over the next several months. After a TBM crew member drilled a hole in the boat's bottom to mount a ground plane and water poured out, the yard bored several hull samples and discovered that the kerfs in the PVC foam core had not been filled with resin or putty. As the author says, the core was "one big limber-hole system." The core itself, though, was in good shape, and firmly bonded to the skins.

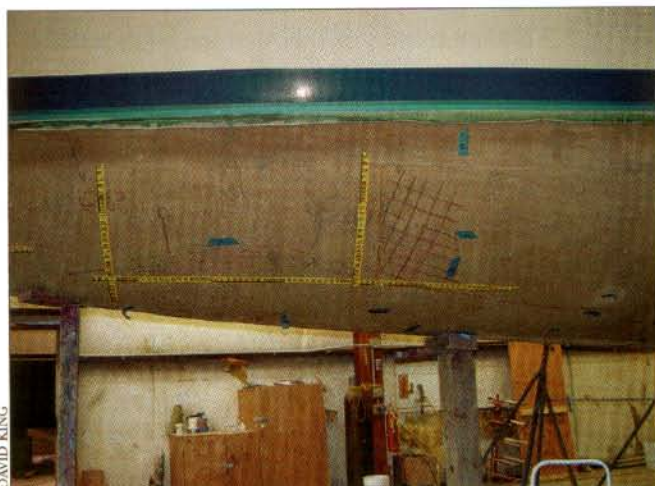
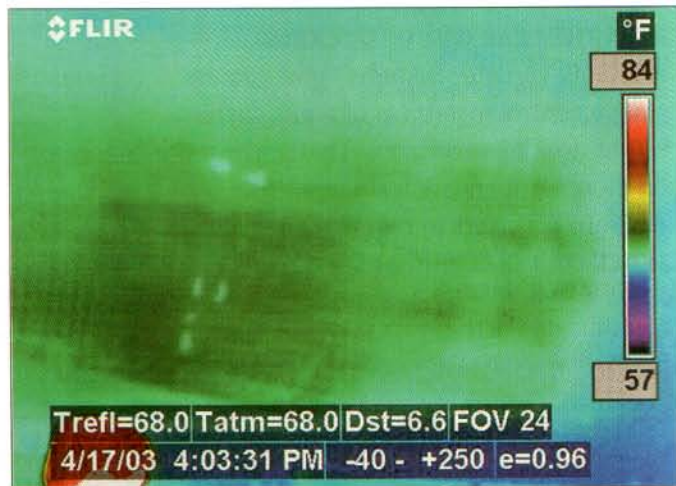
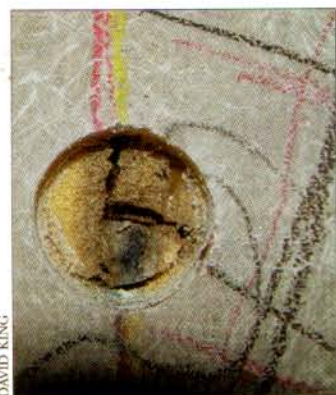
TBM hired Todd Schwede of Todd & Associates to do an infrared scan of the boat's bottom to determine the extent of water intrusion. The photos on this page give a good sense of how the infrared scanning process works. Note the cross-hatched area in the center of the hull in the photo **above, left**. The vertical line to the left of the cross-hatching corresponds to a line demarcating areas of core laid out at different angles. Moisture had migrated from the forward area of the hull (to the left); the moisture was stopped by a putty dam along this line. The moisture buildup shows as the darker area at the left of the scan **above, right**. Note the five whitish dots that imply a vertical line—that's the putty dam. The large red and white spot (partially obscured by screen data) is where TBM drilled through the outer skin to reveal core beneath, shown in the photo **left**. The cracks in the foam core are unfilled kerfs. The author readily admits that it takes a specialist to perform and interpret an infrared scan. On the basis of the infrared survey, TBM determined that the boat did not have systemic core and moisture problems, and that wet areas in the hull could be dried out and relaminated.

To dry out the hull, TBM attached a vacuum pump and ran it night and day for several weeks. The yard moved the pickup point around the hull, guided by Schwede's infrared map.
